**Structural Assessment of Settlement Issues  
École Notre Dame du Cap  
Cap Saint-Georges, NL**

**Department of Transportation and Works**

15 March 2019

Document No. TF19177142-0000-RPT-0001, REV. 0

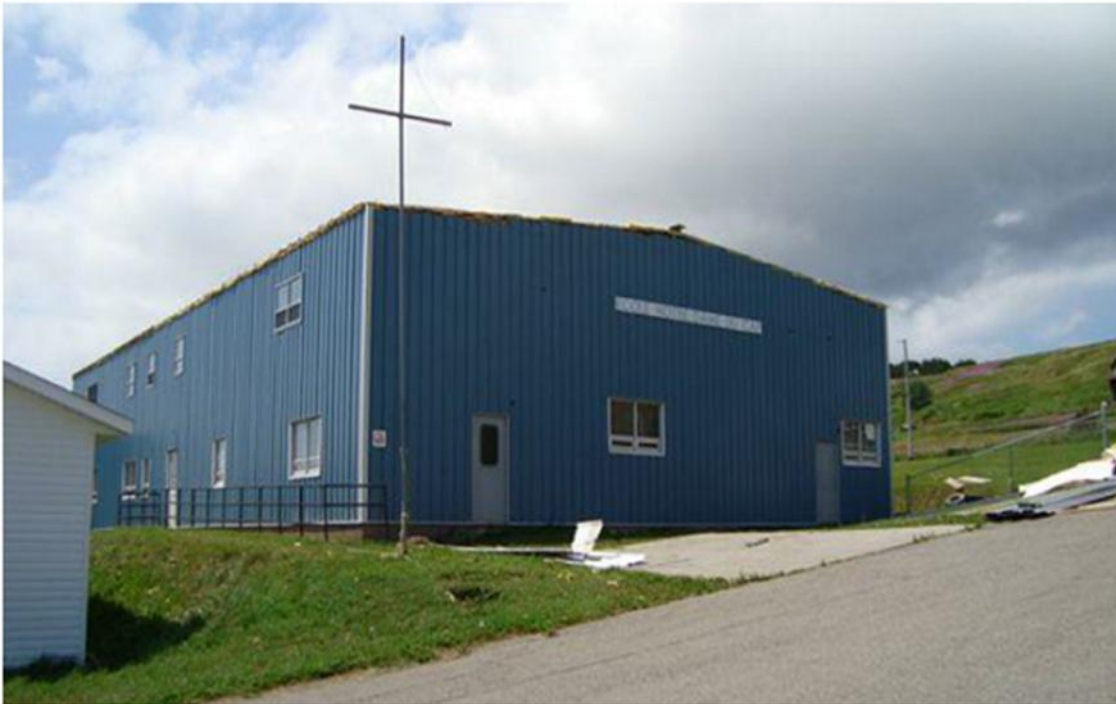
**Figure 1: École Notre Dame Du Cap - View to West**

3. Figure 1 of this report shows that the school building was constructed on the side of a hill. Therefore, to provide a flat surface on which to construct the building's foundations and slab-on-grade, imported fill would have been placed along the southern portion of the building to achieve the required grades. If less than ideal methods were used to compact this imported fill, any foundations or slabs supported by it would be subjected to settlement. Settlements of foundations and slabs in areas that did not require imported fill, (i.e. north portion of the building) would be much less than those areas that did require fill.

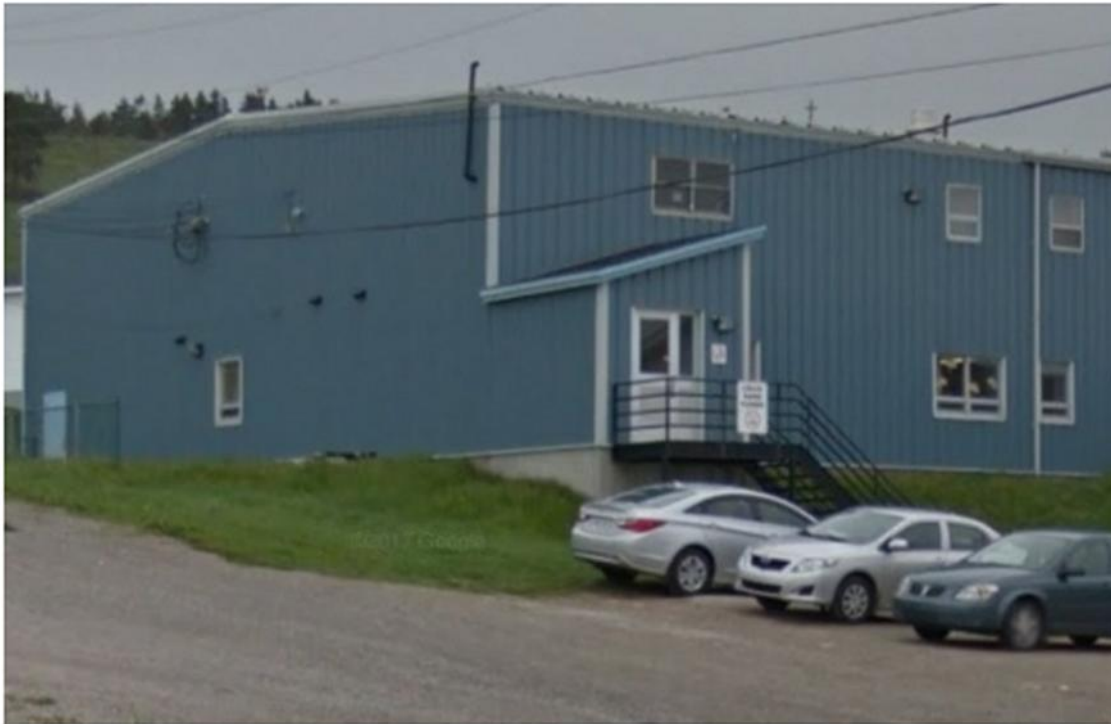
**Figure 2: École Notre Dame Du Cap - View to North**

École Notre Dame du Cap was constructed in 1976. It is a Butler pre-engineered rigid frame building with plan dimensions of 18.3 meters x 30.5 meters. Sometime after initial construction, a building extension at the south-west corner was constructed. This extension can be seen in Figure 2 above.

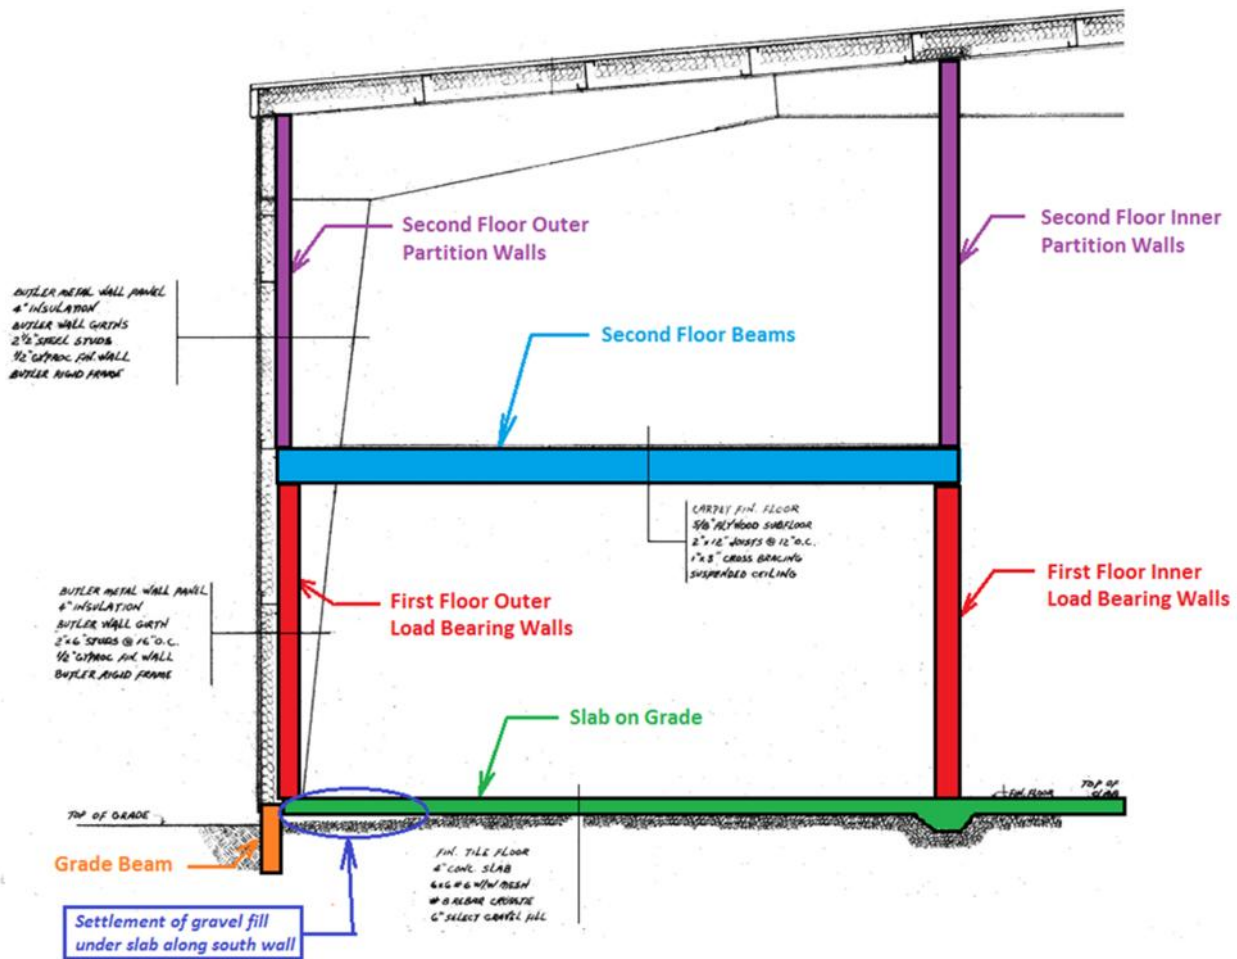
Figure 6: École Notre Dame Du Cap Section View to West

1. The blue coloured beams in Figure 6 support the second floor. These beams are supported at their ends by the red coloured load bearing walls. In addition to the second floor area dead and live loads, the blue beams also support the purple coloured second floor partition walls.

Figure 6 shows an area of settlement along the south edge of the slab-on-grade that approximates what the building is currently experiencing. This localized settlement results in the slab-on-grade needing to act as a cantilever beam over the areas where fill has subsided. However, the slab-on-grade is not designed to act as such. The slab-on-grade used for this building is only 100 mm thick and has no reinforcing steel. The only steel in the slab is welded wire mesh used for crack control. The slab has no flexural capacity to act as a beam. Forcing this slab to act as a flexural member will result in structural failure of the slab.

7. Figure 6 and the associated Butler drawings attached in Appendix C do not show how lateral stability is being provided to the second floor structure. It is clear from the drawings that the second floor is supported vertically by the first floor load bearing walls. What is not clear is how the second floor is supported horizontally to provide the required lateral stability. Without a proper horizontal restraint system, the second floor has the potential to shift sideways. This could possibly lead to a collapse of the second floor. The potential of this occurring increases when the outer load bearing walls are settling and continue to settle downward due to the failed portion of the slab-on-grade under these walls. This downward settlement is progressive and will not stop with time. Such deterioration and the resulting structural distortions and loss of verticality to the second floor support members increase the probability of structural failure and collapse of the second floor.

10. One of the purposes of the grade beam shown in Figure 6 above is to retain the soils under the slab-on-grade. This grade beam spans between the columns. It is supported by the tops of the column footings. Normally, the grade beam is designed to carry its own self-weight plus the lateral pressures resulting from the soil adjacent to the beam. What the grade beam is probably not designed for is to handle the significant lateral surcharge load that results from the outer load bearing walls acting on the failed outer portions of the slab-on-grade. Evidence of overstress in the grade beams can be seen in the exterior photos presented for Photo Zone B in attached Appendix E.

The structural issues described in the previous section show that the École Notre Dame du Cap structure is in a state of progressive failure. Further occupancy of this building should be terminated as soon as possible. The safety of the occupants is currently being seriously jeopardized through continued use of the building.

It is recommended that after the occupants have been relocated from the school, steps be taken to determine the full extent and ramifications of the issues presented in this report. This can then be used to determine the scope of repairs required to restore the building to the required level of safety, stability, and functionality. These steps can then also be used to determine the estimated costs of construction, renovation, and repairs needed for the building. Knowing these costs would subsequently allow the Department of Transportation and Works to determine the feasibility of retaining the structure in an improved, restored and safe state.

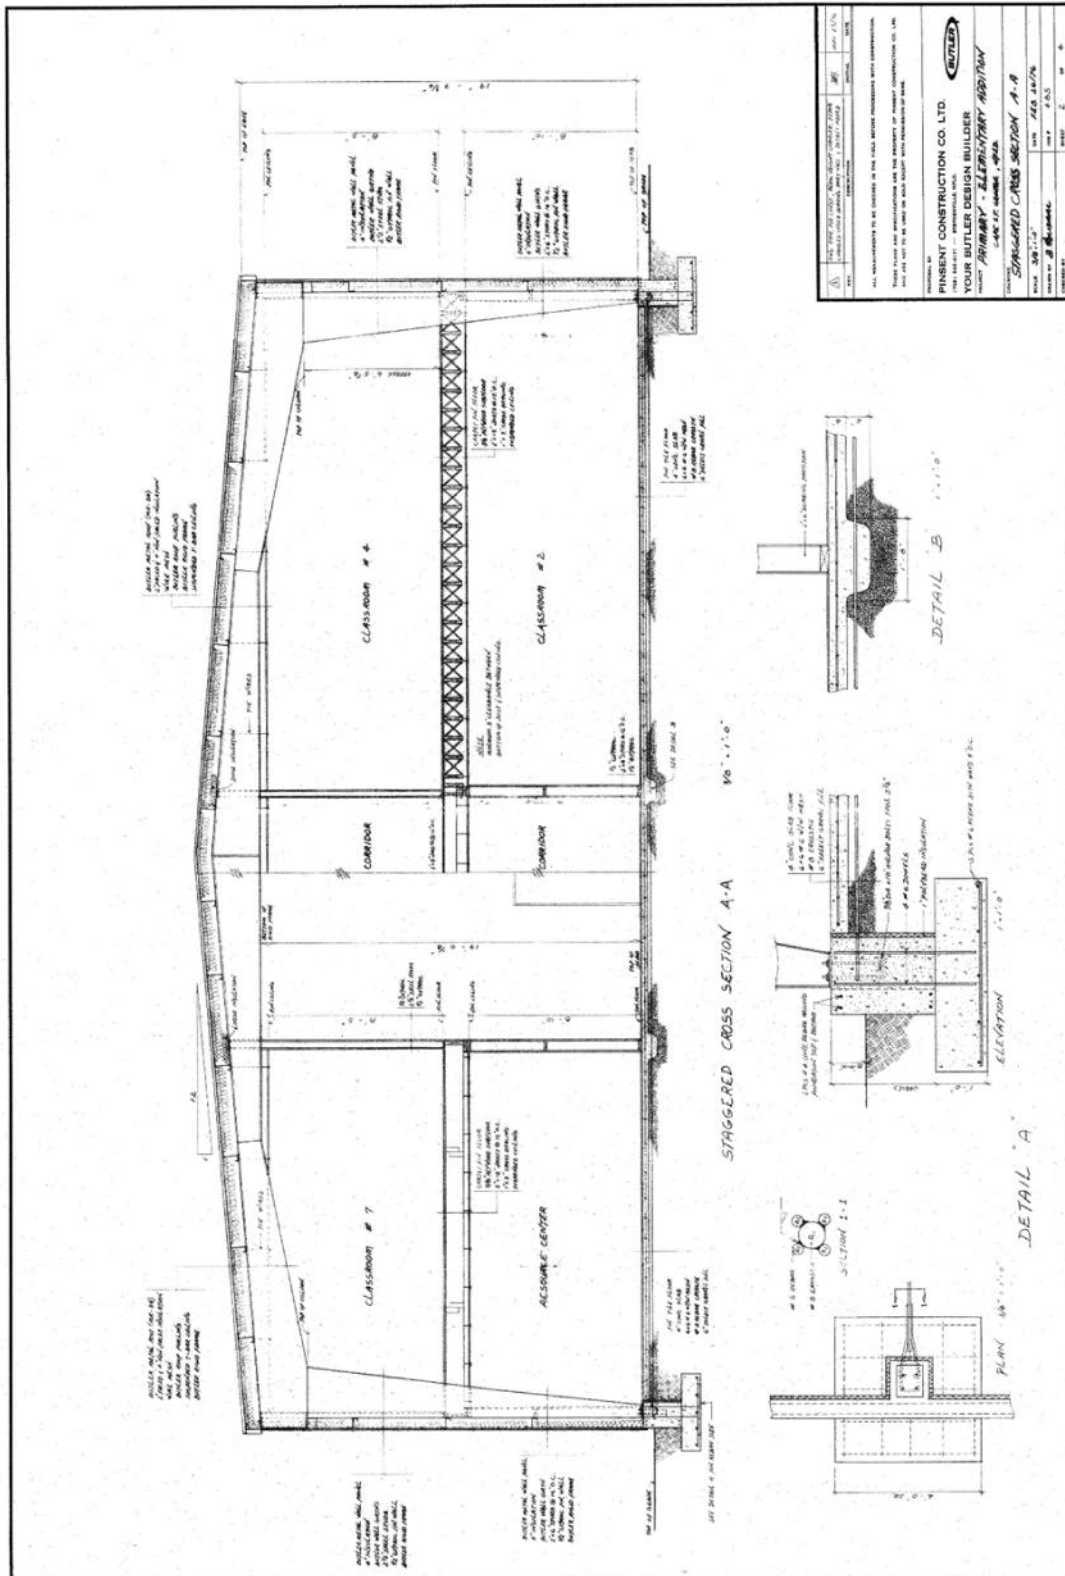
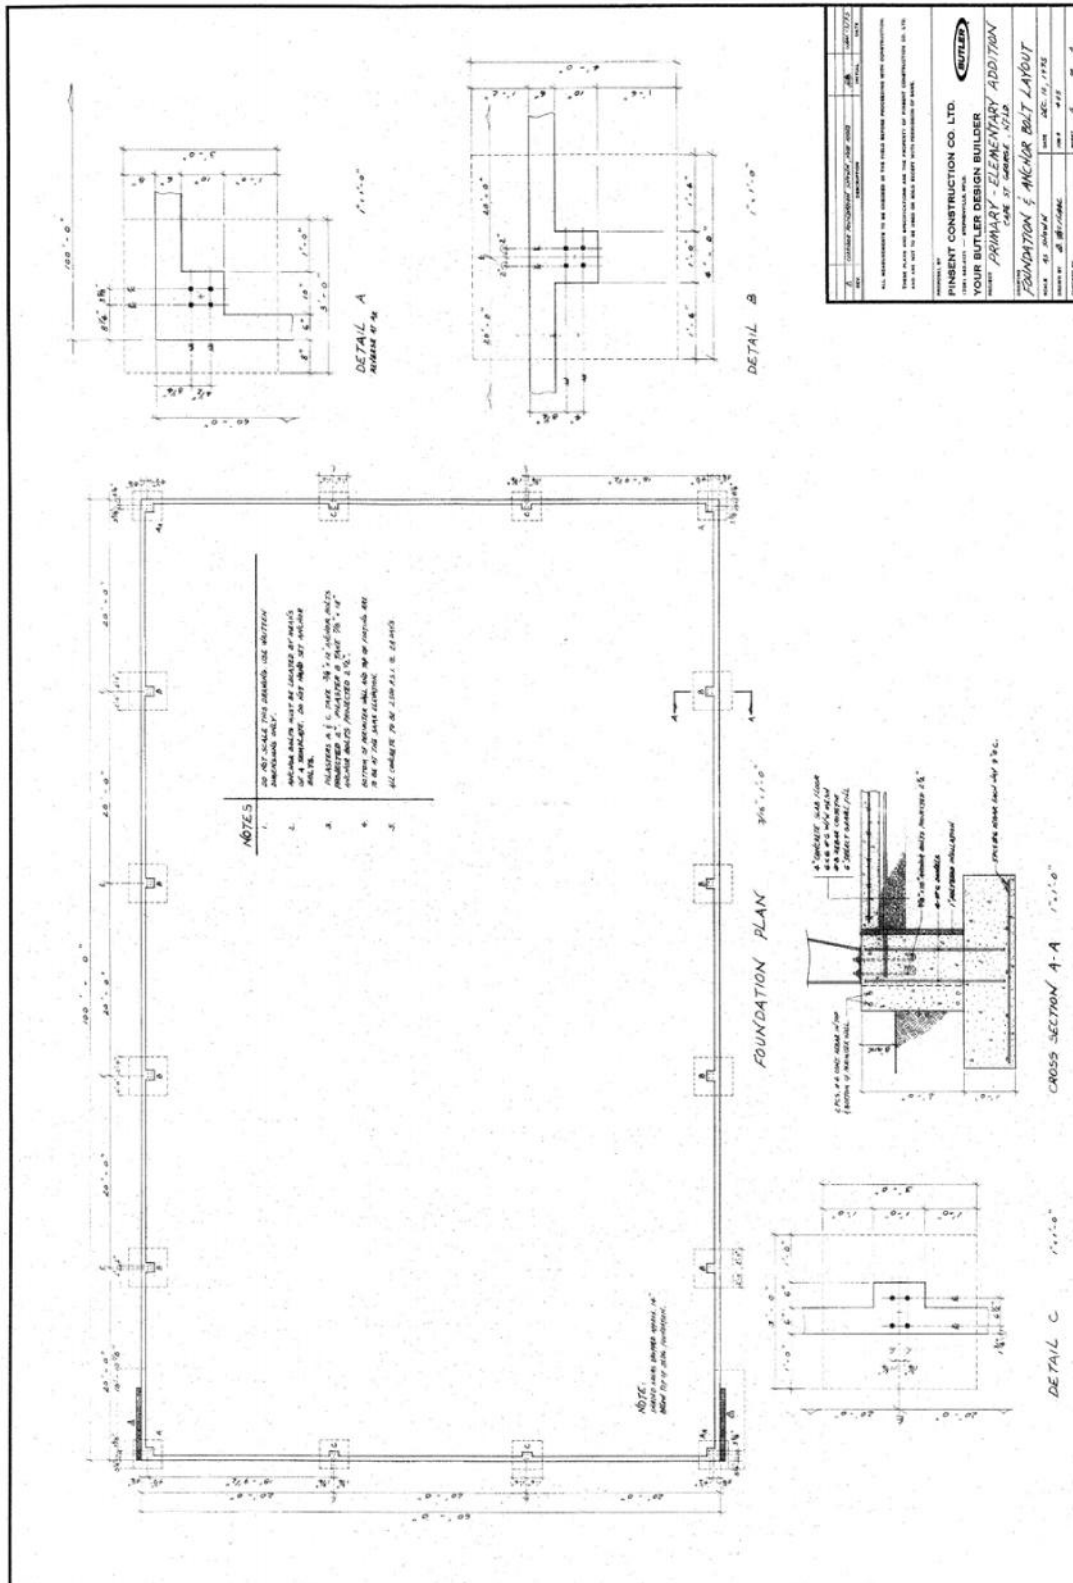
**APPENDIX C: ORIGINAL BUTLER DRAWINGS**

5. Referring to the Butler drawings in attached Appendix C, the columns on opposite sides of the building are tied together with a steel cross tie. This is a common approach in pre-engineered buildings. The tie-rods are used to handle the large horizontal reaction forces that want to push the opposing foundation columns away from each other. With support no longer being provided to the underside of the slab-on-grade and

8. Cross Section A-A from Butler's "Foundation & Anchor Bolt Layout" drawing presented in attached Appendix C shows that the depth of frost cover for the foundations is less than 2 ft. – 4 in. (711 mm). Normally, frost cover required for this school's location would be at least 1800 mm. Therefore, because the foundations do not have sufficient depth below grade, it can be concluded that they have been subjected to many cycles of frost heaving since the structure's construction in 1976.

Cross Section A-A shows that 1 inch thick insulation was attached to the inner face of the grade beam and inner face of the column pilasters for the entire perimeter of the building. This insulation only extends from the top of the footings to the top of the grade beams. The presence of this insulation does nothing to prevent the effects of frost acting on the foundations and the underside of the slab-on-grade. Therefore, it can be concluded that the outer portions of the slab-on-grade have also been subjected to many cycles of frost heaving.

9. Detail B from Butler's "Staggered Cross Section A-A" drawing presented in attached Appendix C shows a thickened portion of concrete for the slab-on-grade at the locations where the inner load bearing walls will be located. No reinforcing steel has been added in the longitudinal direction parallel to the walls above.

Without longitudinal reinforcing steel, the thickened portion of the slab-on-grade does not have any flexural capacity. The thickened portion does not need to have any flexural capacity provided that the supporting soil under it is optimally compacted, has not settled with time, and has no significant vertical deformation due to applied loads from above. However, it is most likely that the existing soil conditions do not have these ideal characteristics. Therefore, these thickened portions of the slab-on-grade will be subject to flexural stress. Without longitudinal reinforcing, these thickened areas will not be able to accommodate the stresses imposed on them and structural failure will result. This is a serious consequence since all the load from the inner load bearing walls that are used to support the second floor is being supported by a system that has experienced structural failure.
